CARR-713

Amos Shaeffer Farm  
Westminster (vicinity)

# Maryland Historical Trust State Historic Sites Inventory Form

Survey No. CARR-713

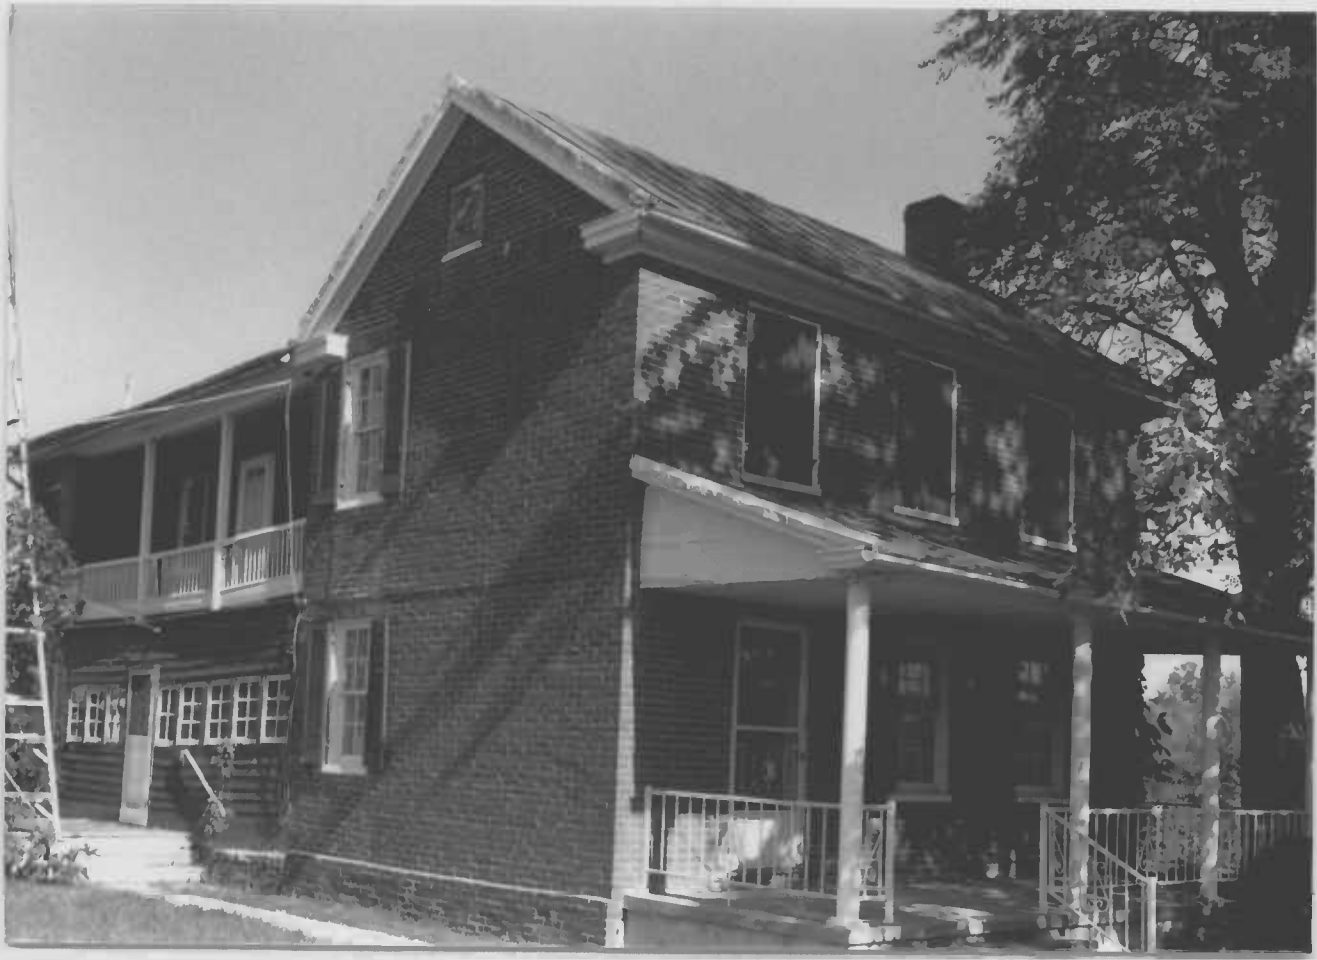
$\frac{2}{3}$

House - Southwest and Southeast elevs.

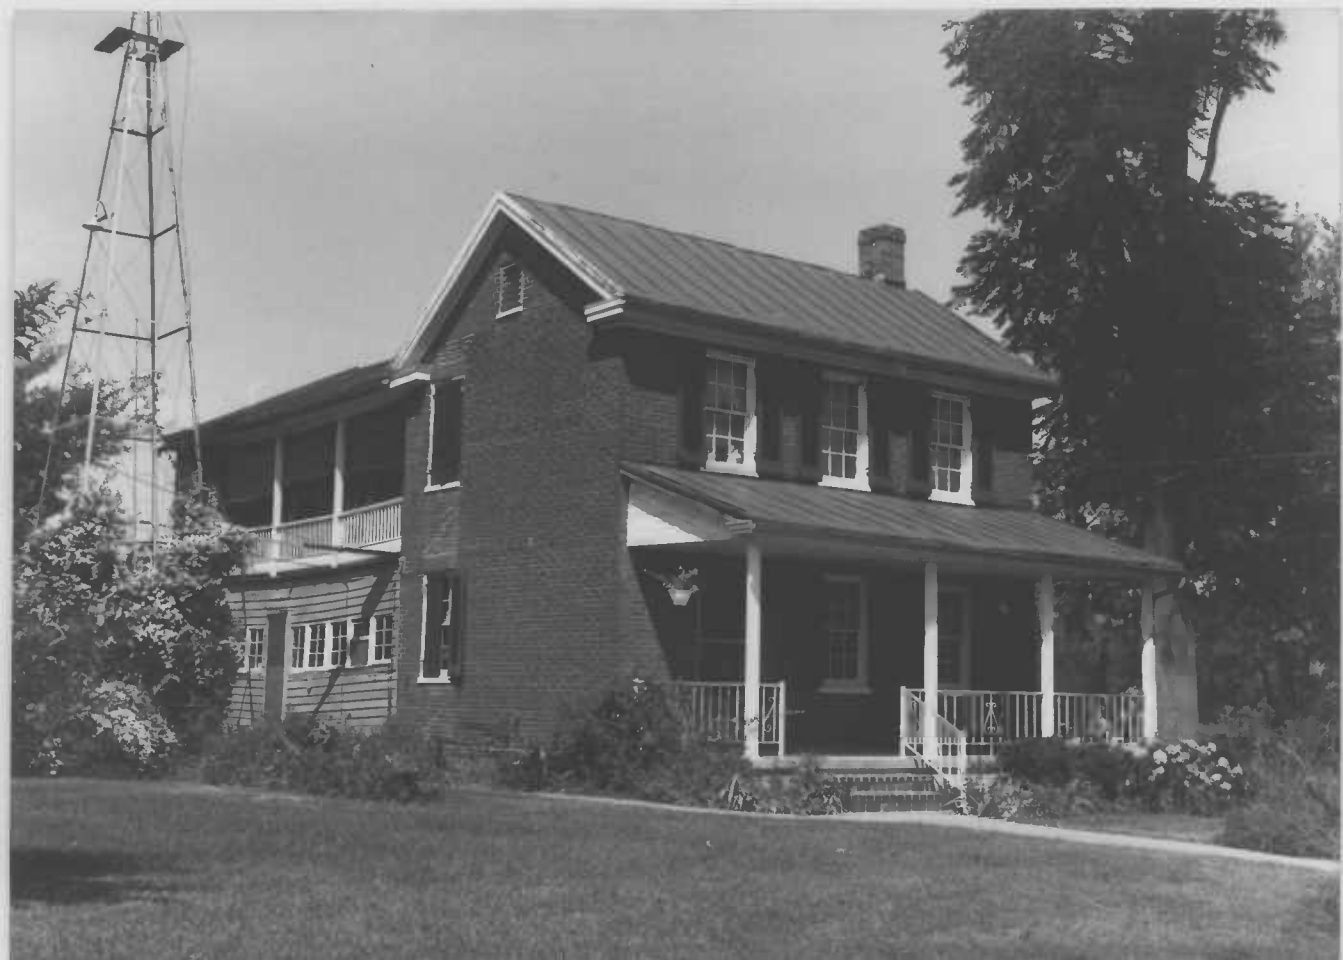
1. CARR-713 222 CRANBERRY ROAD
2. Carroll County, Maryland
3. Joe Getty
4. August 1983
5. Md. Historical Trust, Annapolis, Md.
6. South and east elevations  
(camera facing northwest)
7. 1/1
